MIDLANDS THERMAL IMAGING

**This Inspection was
carried out on a home in
Rathcabbin, Roscrea, Co.
Tipperary**

This report has been completed by Katie Masterson.

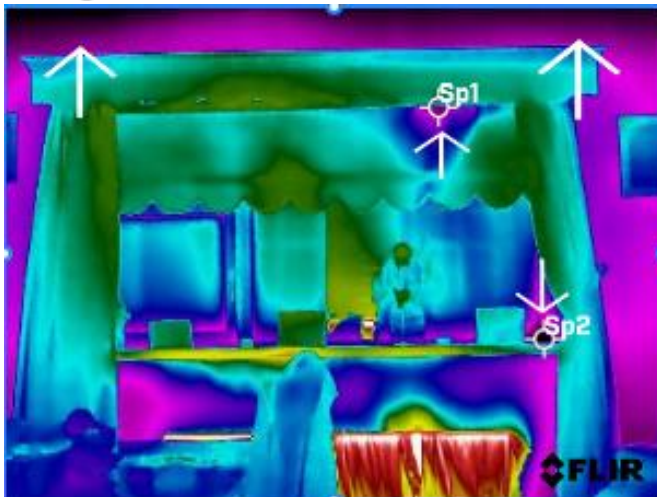
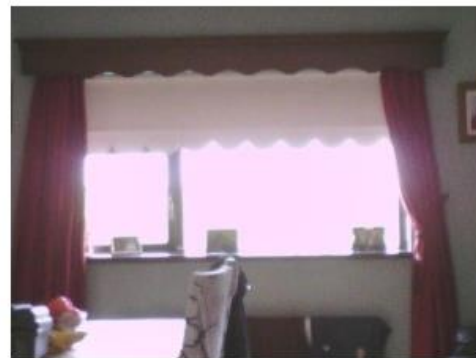
Image one : There are two Spots (Sp1 14.3 °C and Sp2 11.9) in the image that show significant heat loss, It is possible to feel air filtration in these areas. There is a large area above the window towards the ceiling that appears to be losing heat also, this can be seen as the black area at the top of the image.

Overall, the inspections indicate the kitchen the window seals may need to be looked at as it seems there are spots of air filtration. There is also heat loss running along the top of the walls which may be due to insufficient insulation however this should be investigated further. There is significant heat loss above the extractor fan area which may be from an air vent from the extractor fan.

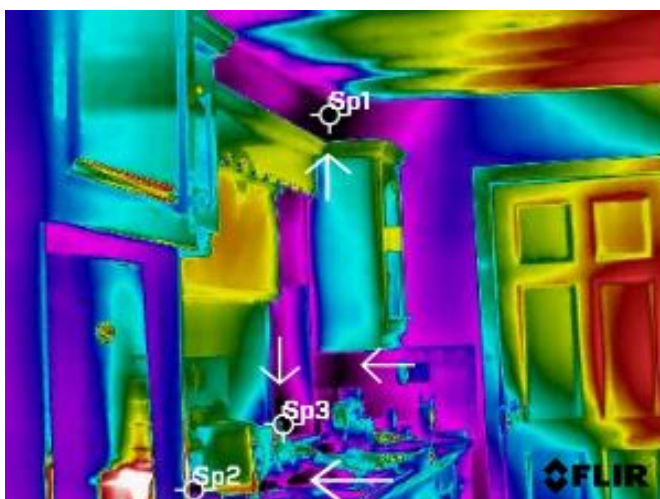
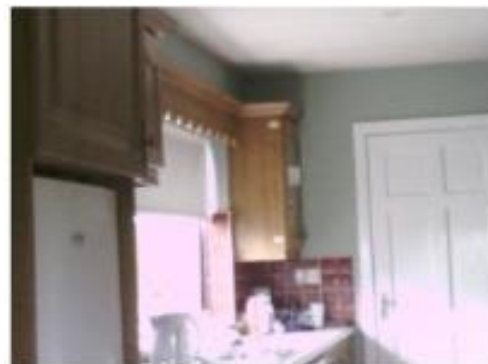
Image two

Image two: There is significant heat loss in the corner of the kitchen and above the kitchen cabinet of 7°C from room temperature. There is also cold spot running under the window ledge pointed out by the arrow.

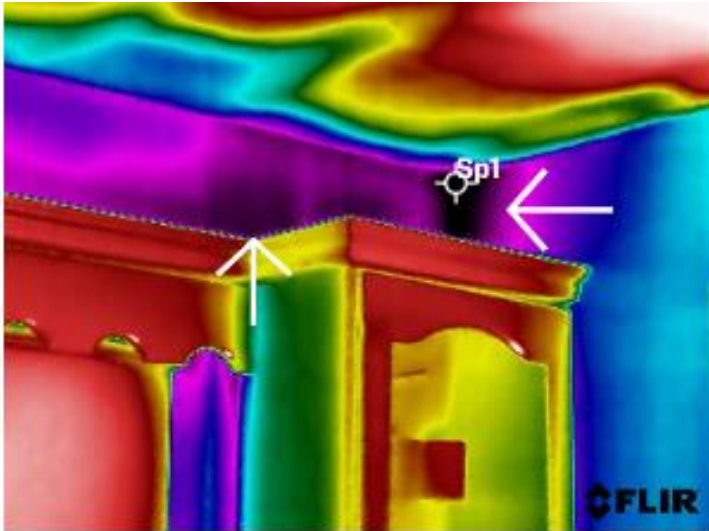
Image three

Image three: A closer look at the cold spot above the kitchen cabinet in image two. It seems to run along the top of the wall and meeting with the problem area in the next image.

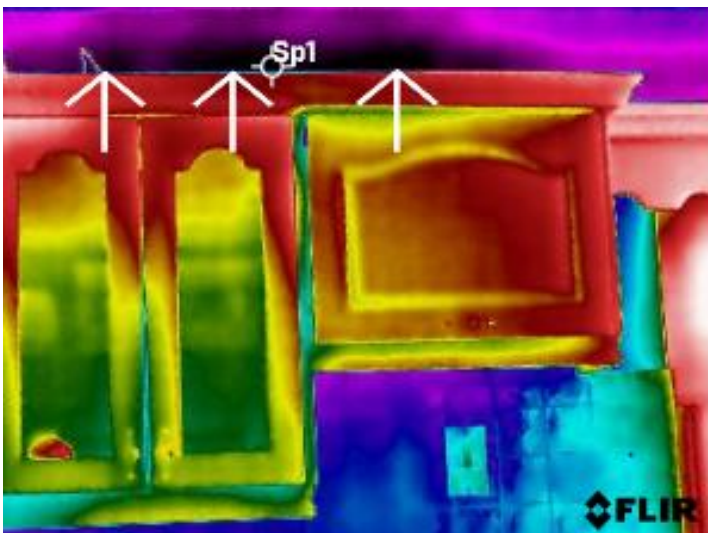
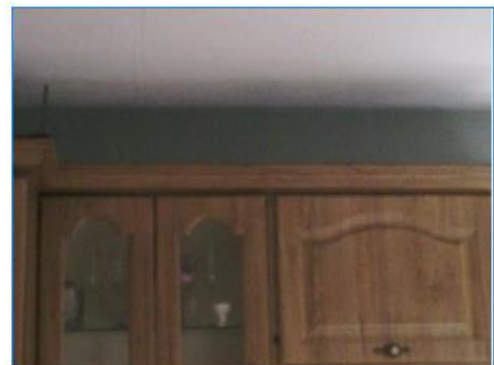
Image four

Image four: There is a loss of heat above this cabinet/extractor fan of up to 7°C. On inspection there is an open hole in the wall here.

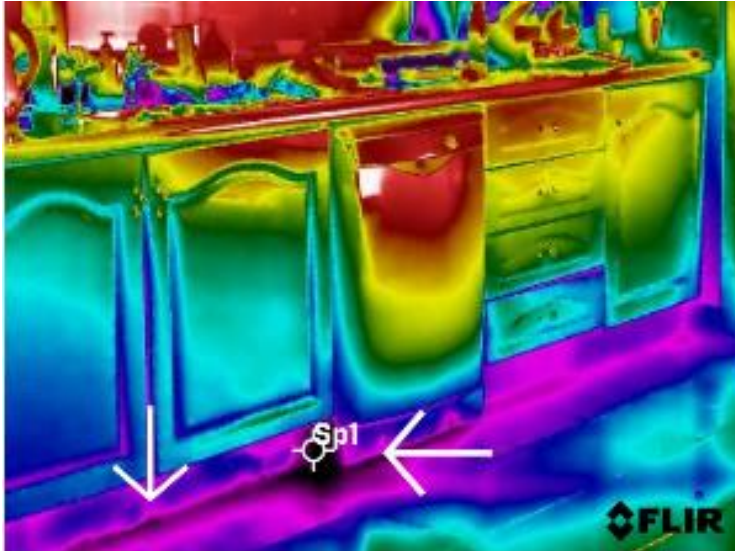
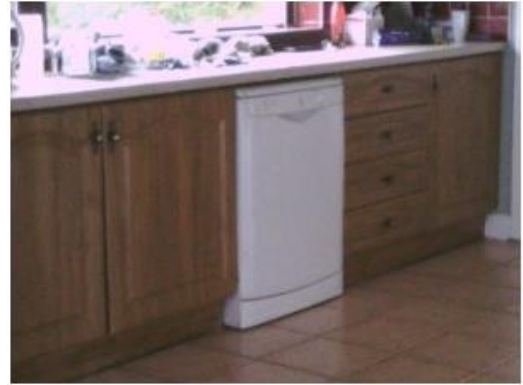
Image five

Image Five: The seems to be air filtration coming through the side of the dishwasher which flows out underneath the kitchen cabinets also.

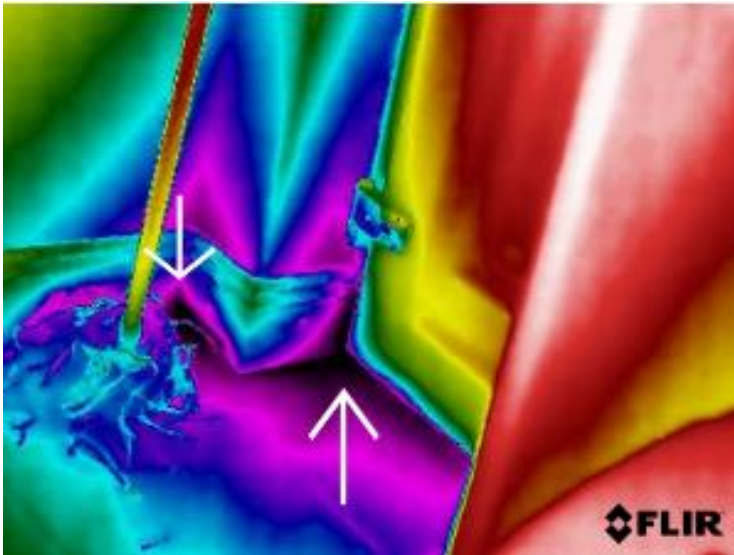
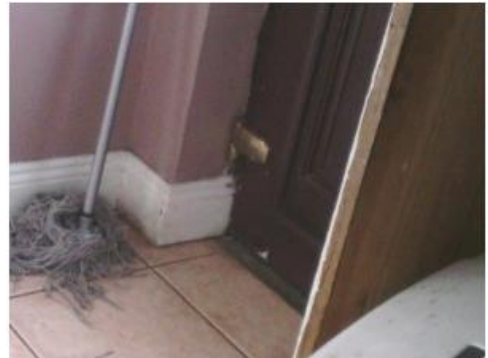
Image one

Image one: There is a temperature difference of up to 10°C in this section. There is air filtration here and it also appears from under the skirting board.

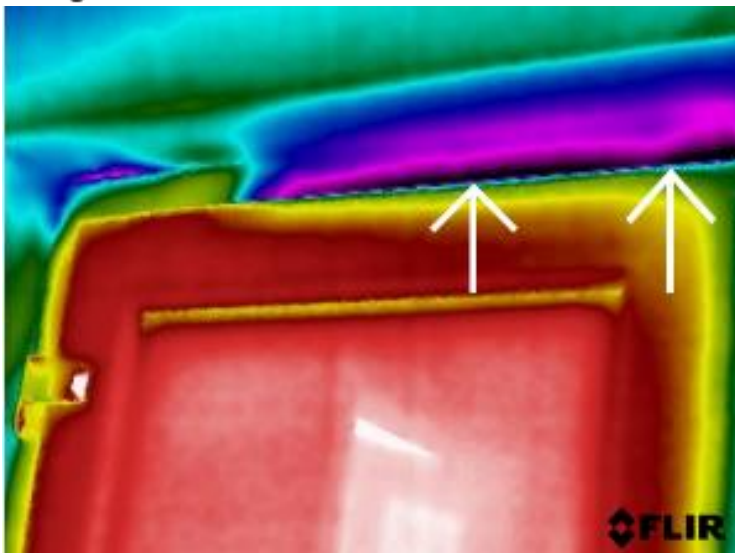
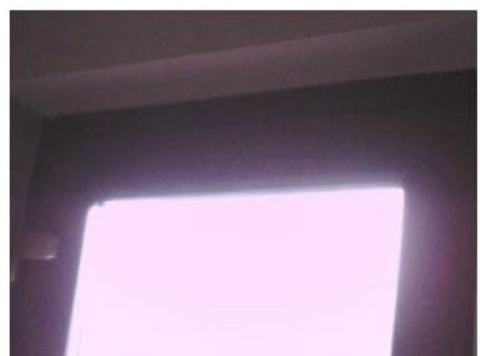
Image two

Image two: Indication of air filtration passing through the seal of the door here shown by arrows with a difference of over 10°C.

The images highlight a draft coming through areas of the back door which may indicate that the seal on the door may need replacing. The heat loss running along the top of the wall may be due to insufficient insulation and may require more advise.

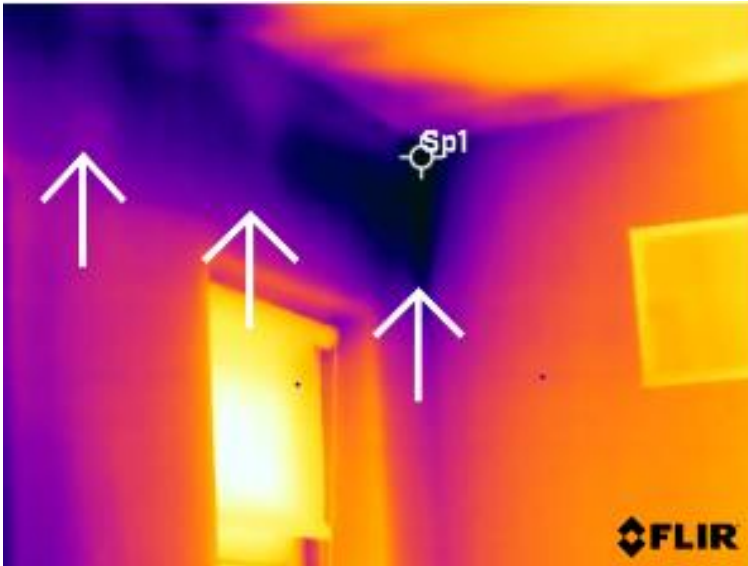
Image three

Image three: I have selected a different colour palette on this image to highlight the difference in temperature running along the top of the utility wall which can be seen as the darker area. There is up to 7°C heat loss in this area.

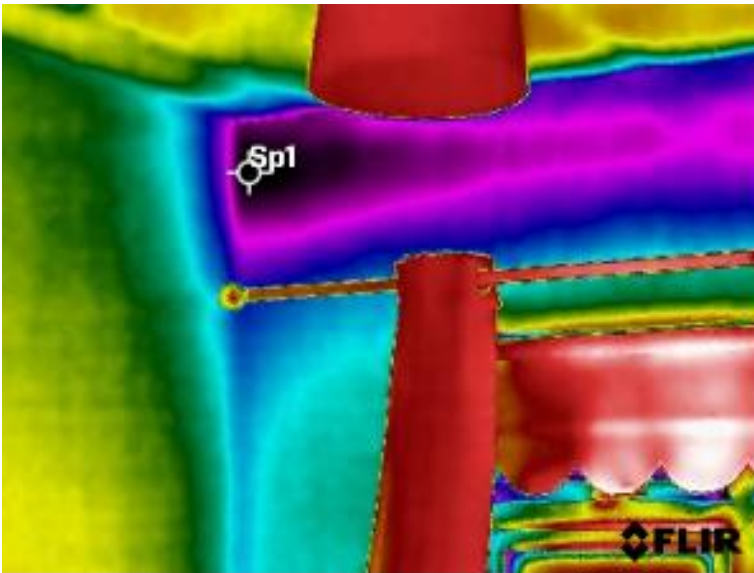
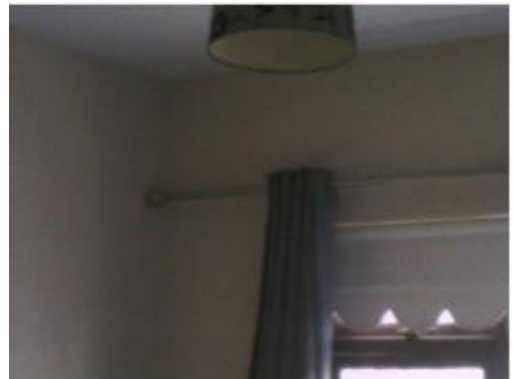
Image one

Image one: Heat loss of up to 8 °C above the window that runs across and meets with the problem area in image two below.

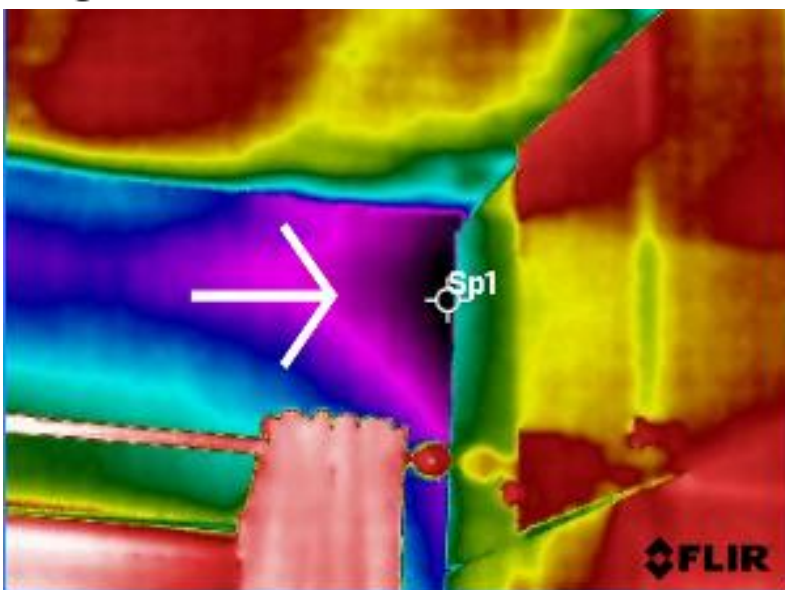
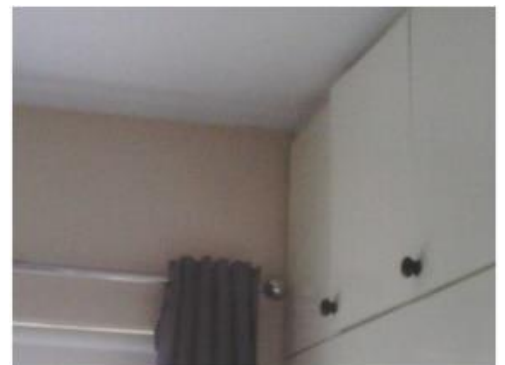
Image two

Image two: Heat loss can be seen on the right side above the window which as explained previously, seems to run across the top of the window.

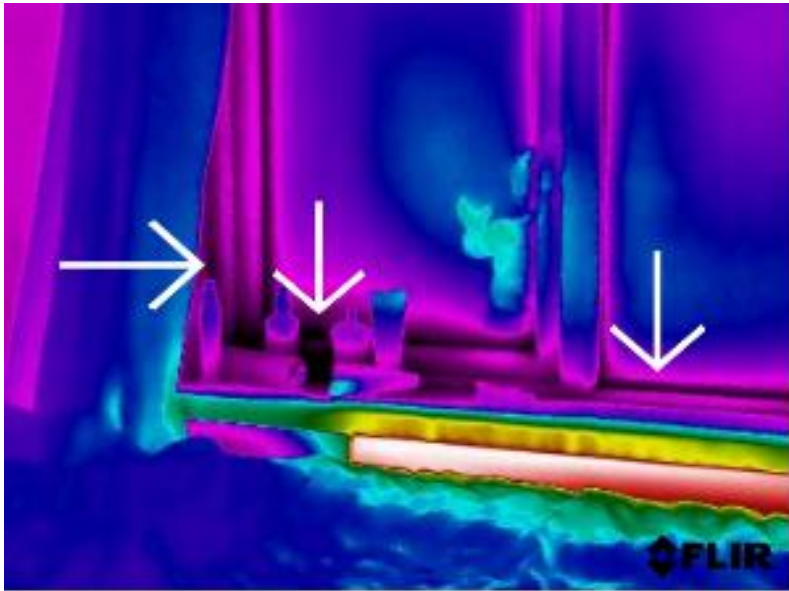
Image three

Image three: It is obvious from this image that there is heat loss here. The temperature drops up to 9°C in the corner of the window.

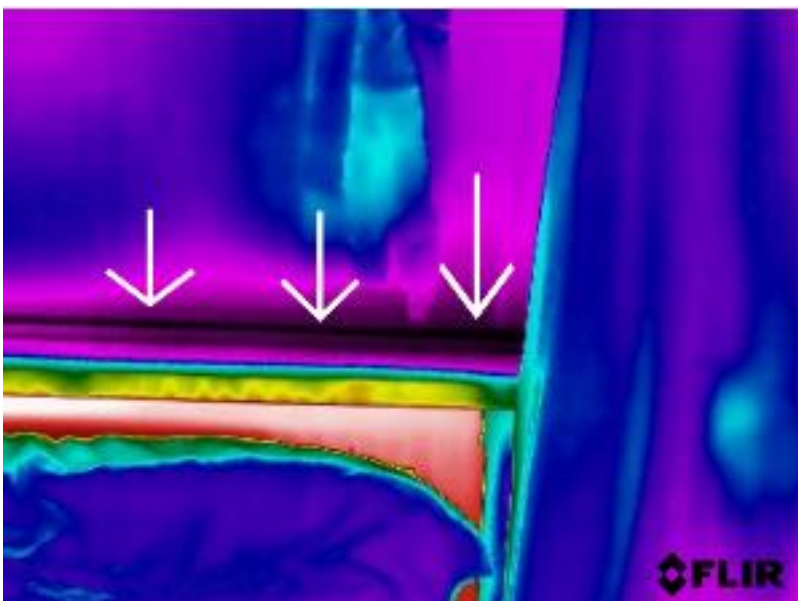
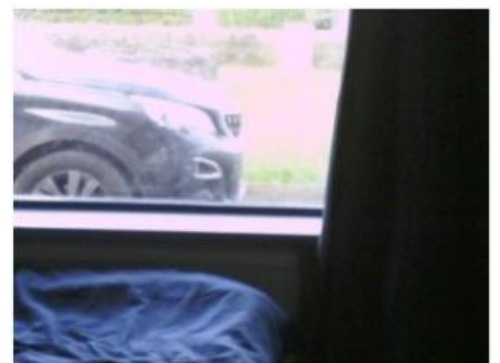
Image four

Image four: As before, this image indicates heat loss on this section of the window.

The inspection of this room has shown heat loss in the top corners of the wall to the front of the house. It seems that this heat loss runs across the top of the window. This is most likely caused by issues with insufficient insulation in this area, however, this should be investigated further. There is obvious air filtration around the window which may be due to the seals needing replacing.

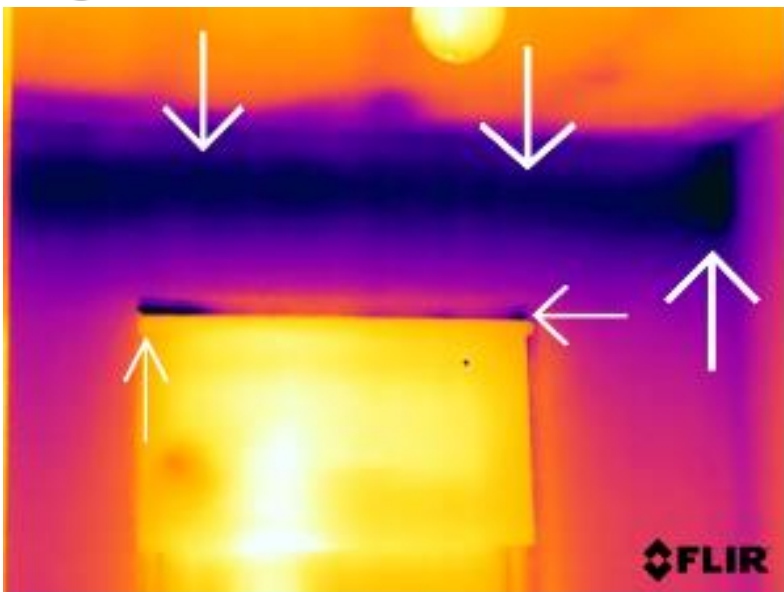
Image one

Image one: There is air filtration coming through two separate areas at the top of the window. It is also clear from the image where heat is being lost across the top of the wall with the corner being the coldest spot at 11°C.

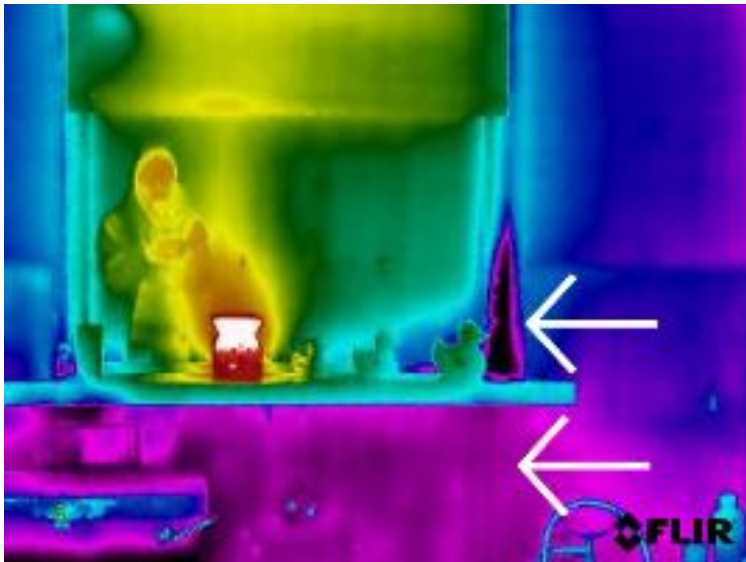
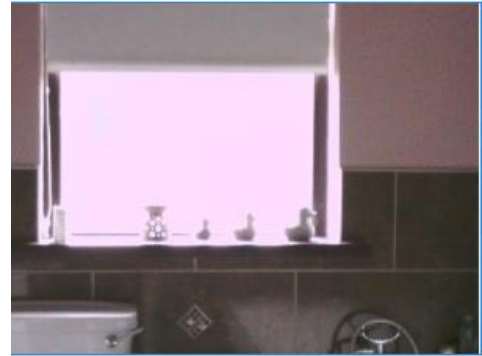
Image two

Image two: There is another large area of air filtration appearing in the bottom right side of the window with a temperature drop of 6°C. It appears there is heat being lost from beneath the window also as shown in the purple colour in the image.

The inspection in the bathroom shows areas of heat loss around the windows which may be due to issues with the sealing. It seems to be becoming a common issue in the walls above and below the windows are losing heat which may be due to insufficient insulation which should be investigated further.

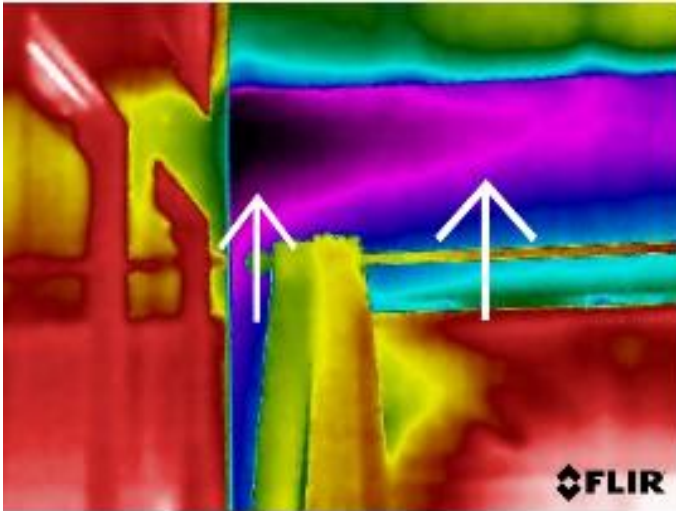
Image one

Image one: This image shows problems with heat loss at its most in the corner however runs across the top of the window.

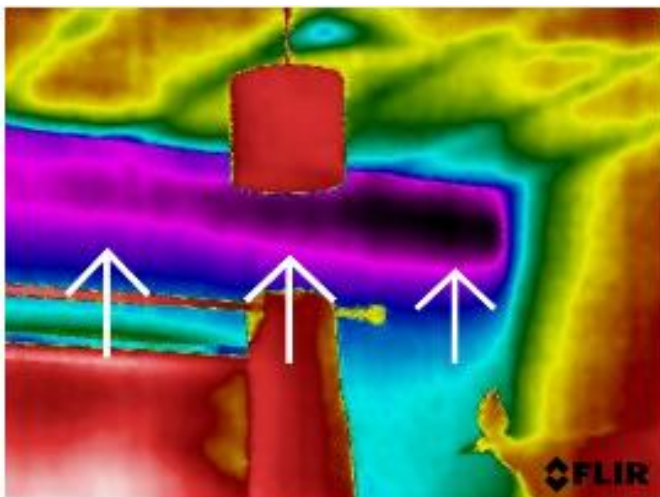
Image two

Image two: Heat loss appearing across the top of the window and to the corner of the room. Temperature difference of 7°C in this area.

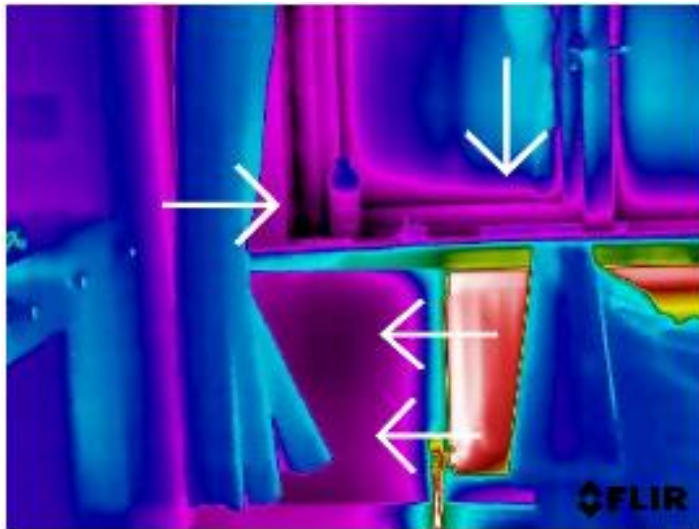
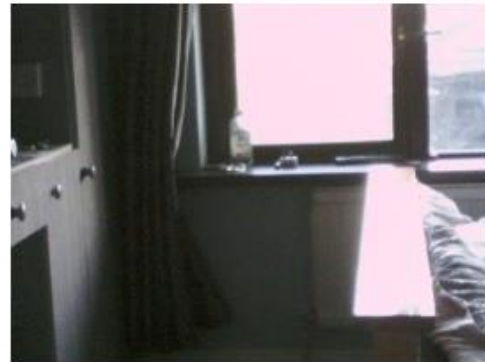
Image three

Image three: The image indicated heat loss in the wall under the window shown as the purple colour in the image. There is air filtration through the corner of the window.

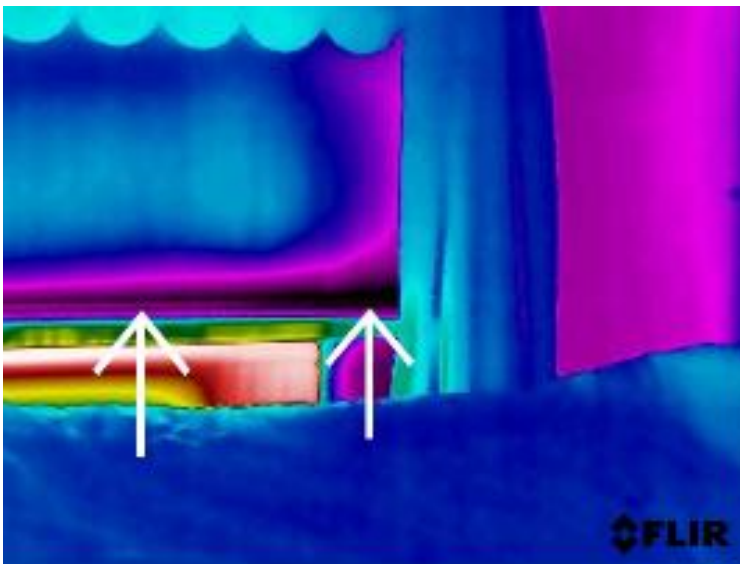
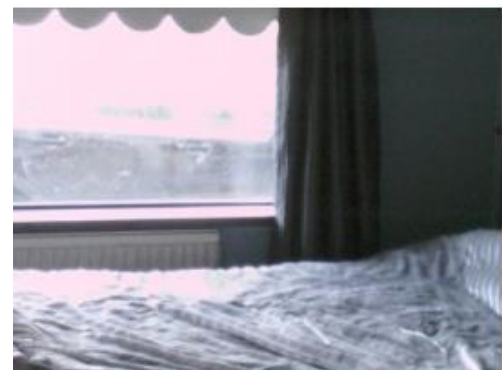
Image four

Image four: Air filtration can be seen here through base of the window.

In this room there is that cold spot running across the wall between the window and ceiling which may be due to issues with insulation that should be investigated further. It is also clear that there is cold air coming through the base and into the corner of the window which can be caused by a poor seal on the window.

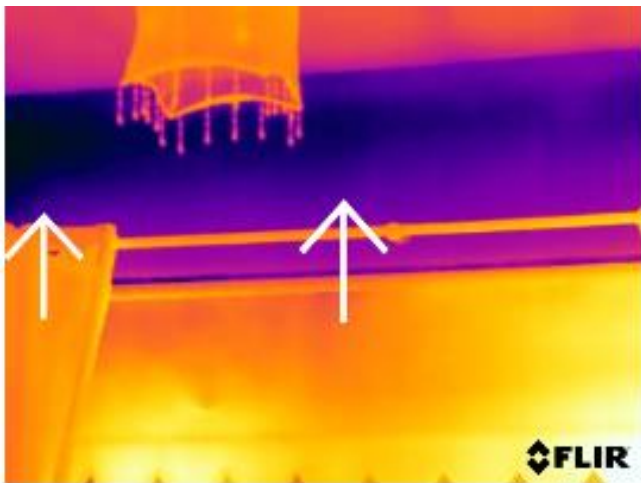
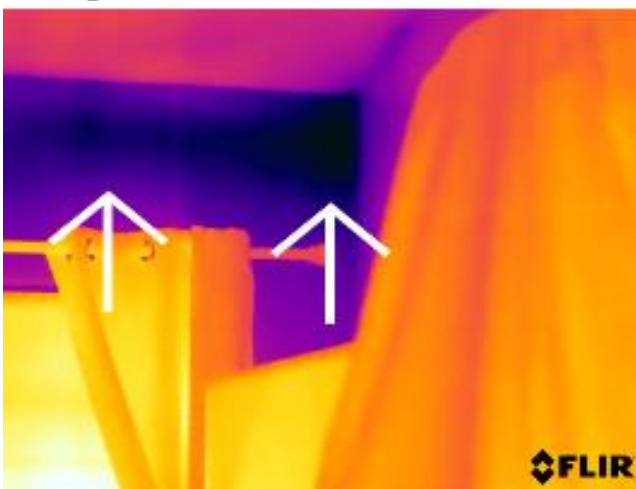
Image one and two: Obvious heat loss above the windows here. There is a temperature drop of 8°C.

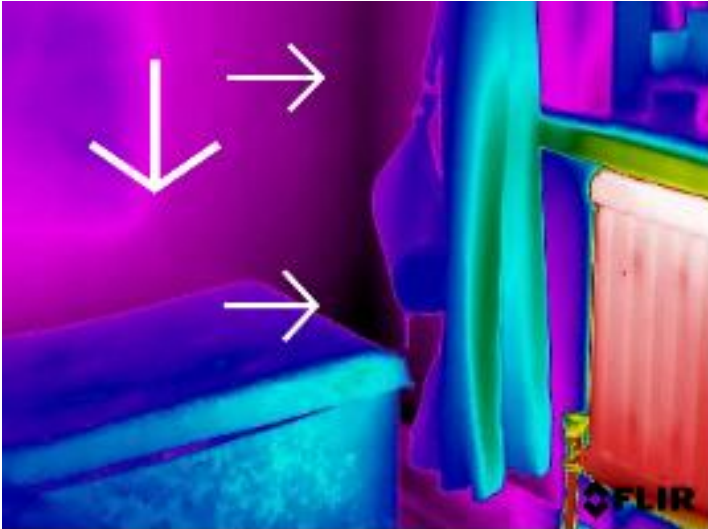
Image three

Image three: Shows heat loss in the corner of the room and towards the skirting board which is highlighted in the next image.

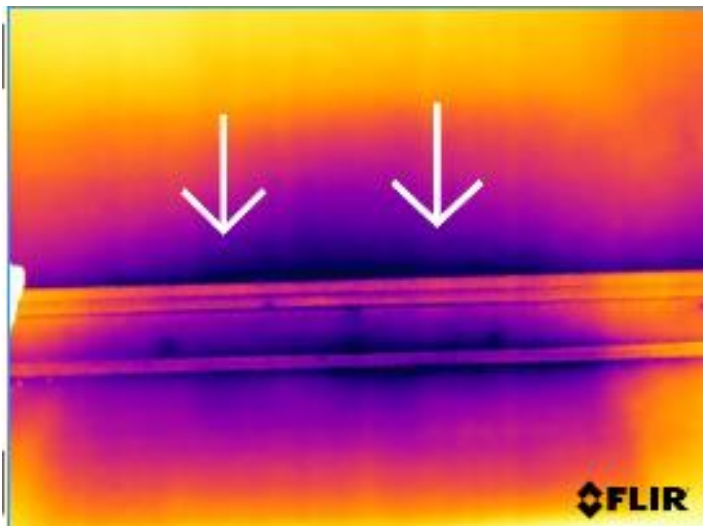
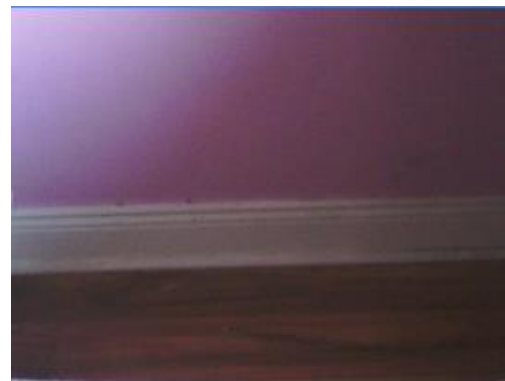
Image four

Image four: I have changed the colour palette here to highlight the change in temperature. There is heat loss of up to 9°C here.

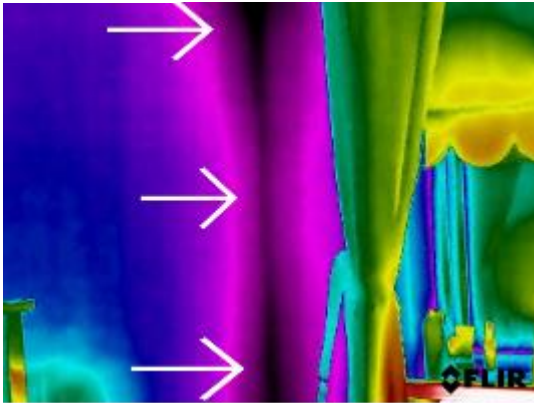
Image five

Image five: Loss of heat appearing in the corner of this room from top to bottom.

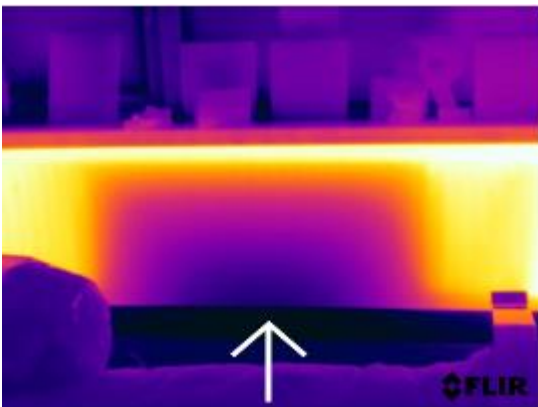
Image six

Image six: The radiator is not working at full capacity.

The inspection in this room indicated that there may be issues with insulation. The areas of heat loss seem to be mostly the top, bottom, and corners of the back wall as well as the sites above and below the window, however it should be advised that this be investigated further. The radiator needs attention in this room. It may need to be bled.

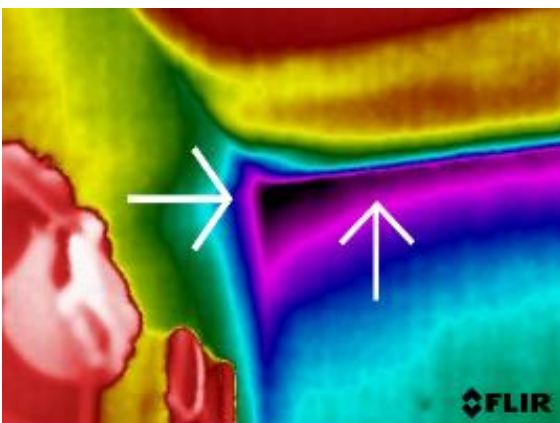
Image seven

Image seven: Cold spot is visible in top right corner of the room. The temperature difference here in 9°C.

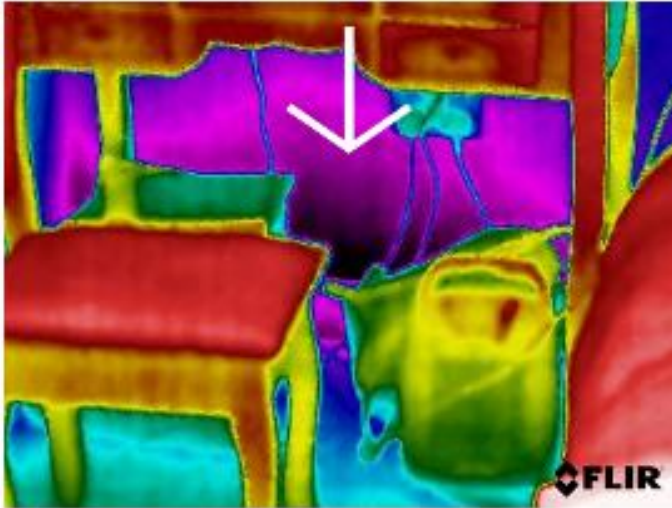
Image eight

Image eight: Cold spot can be seen behind vanity. Probably the same case as image four with the skirting board in this room.

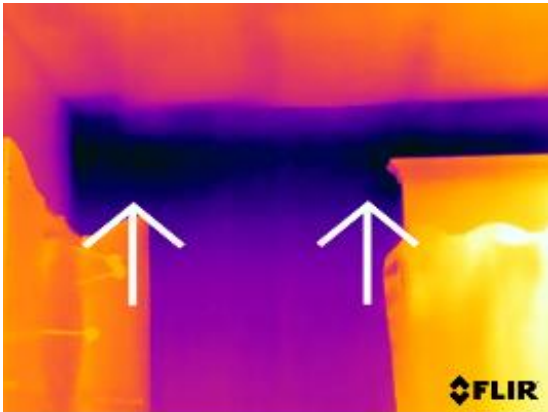
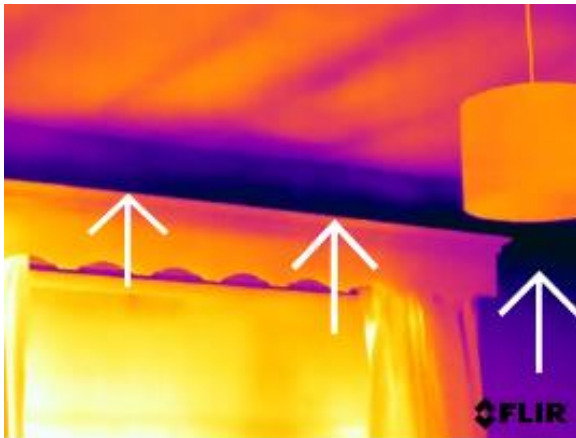
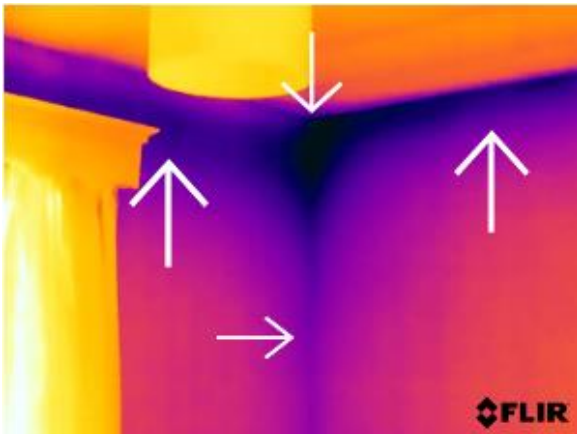
Image one, two and three: Loss of heat running between top of window and ceiling that continues across the back wall. Temperature difference is 8 °C in this area.

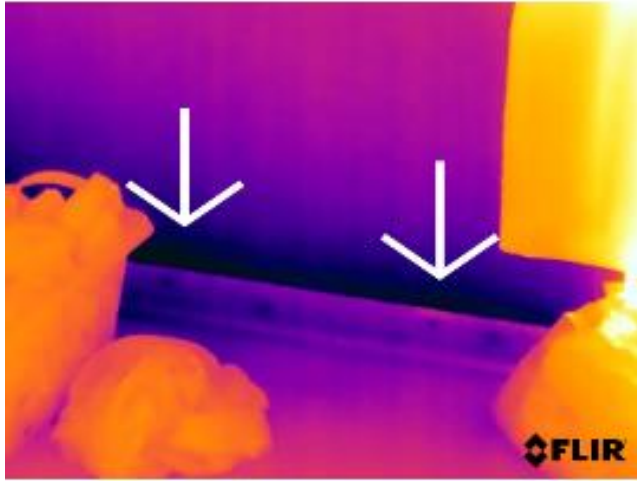
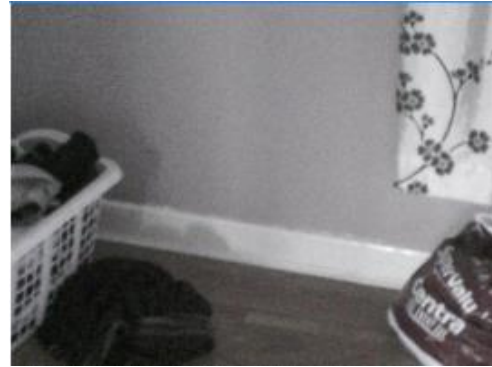
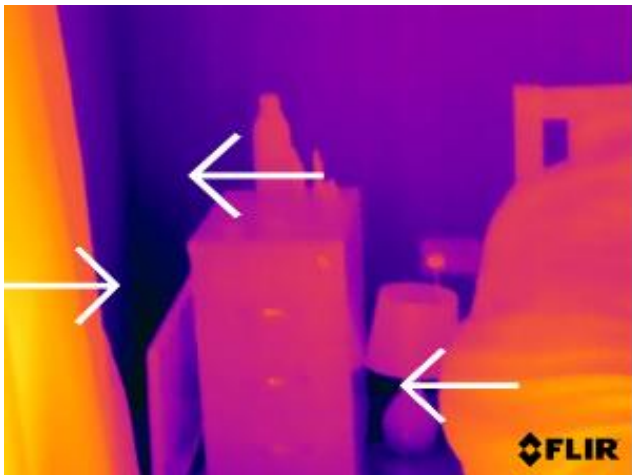
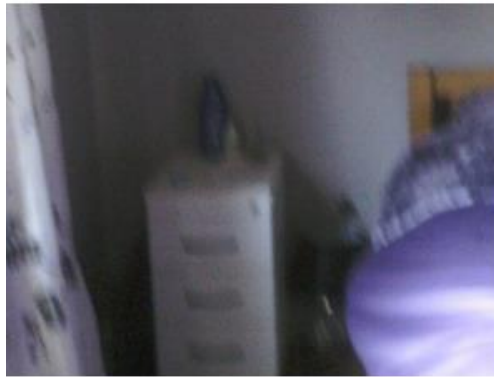
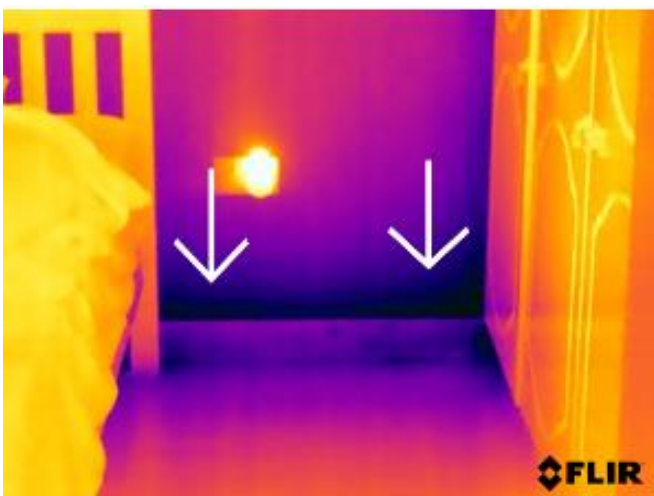
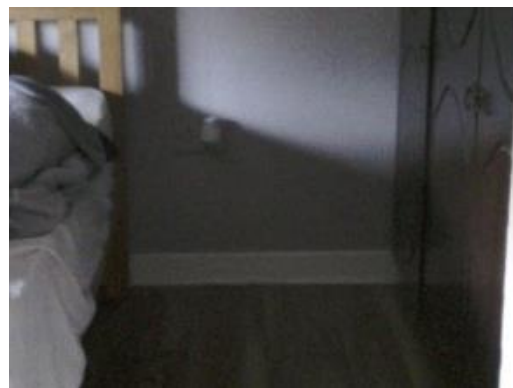
Image four, five and six: heat loss of up to 8°C is visible along the skirting boards in this room. The area of heat loss can also be seen running up the corner wall also by the bedside drawers.

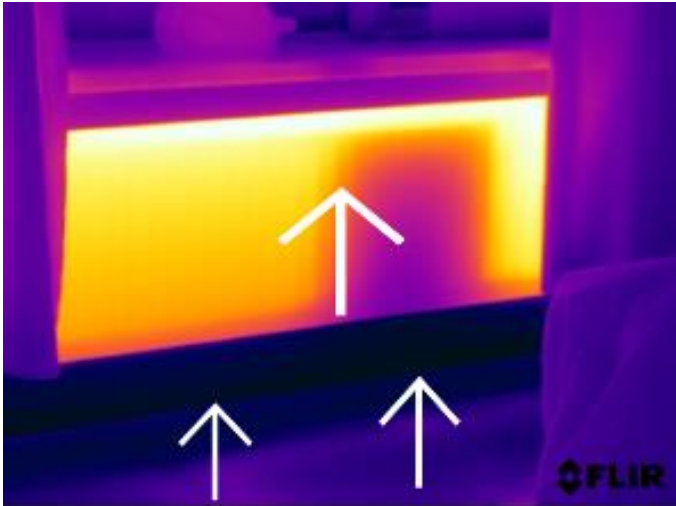
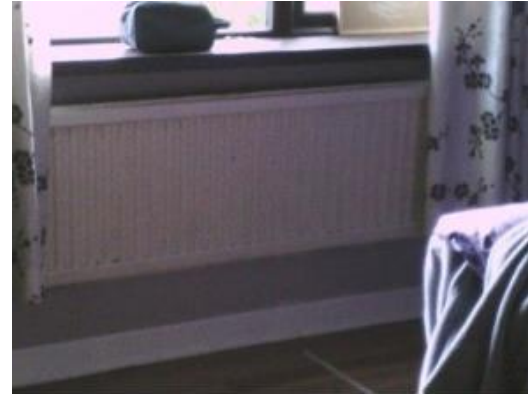
Image seven

Image seven: The radiator in the room is not working at its full capacity.

The inspection in this room reveals that there is significant heat loss in the corners of the room and as seen in other rooms there is a section running above the window that may be due to lack of insulation that may need to be looked at further. There is heat being lost also along the skirting boards in this room and can be seen in the back wall, in the corners and along the bottom the walls. This may also be from insufficient insulation that requires more advise. The radiator might need to be bled as there is a cold spot that can be seen in the centre.

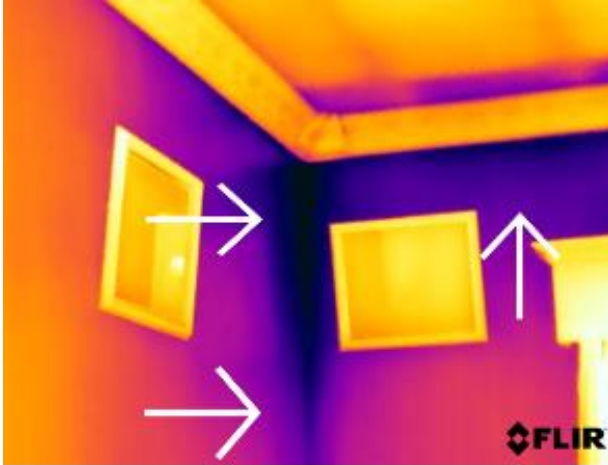
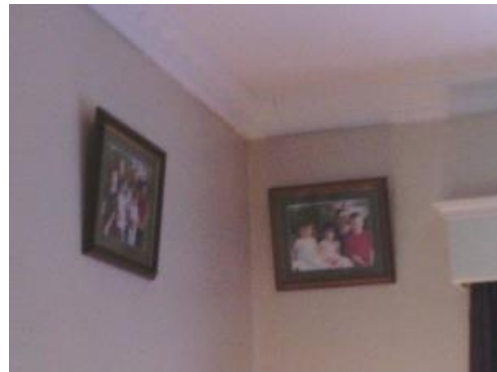
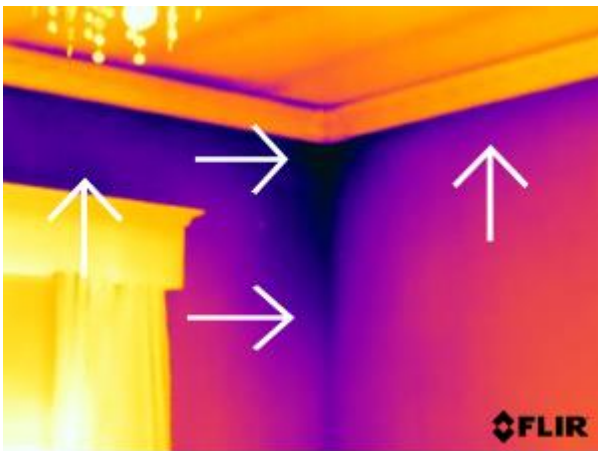
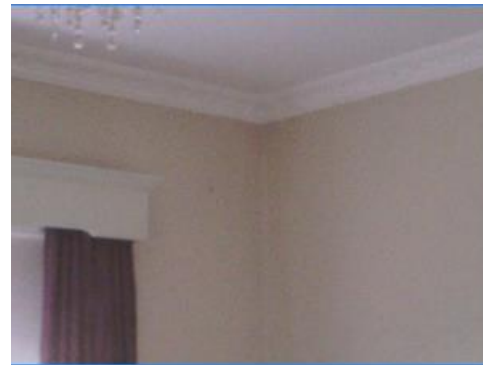
Image one and two: Heat loss visible in the top corners of the room that run between the top of the window and the ceiling.

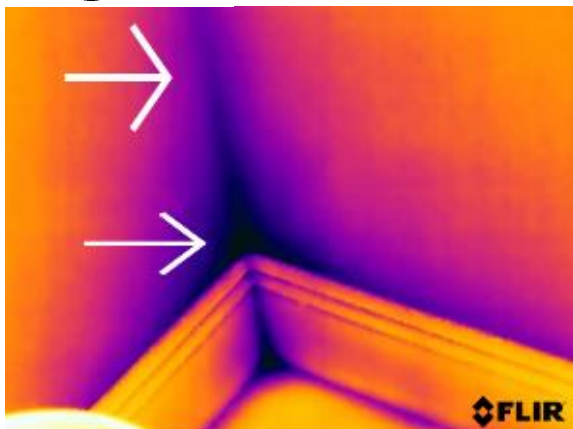
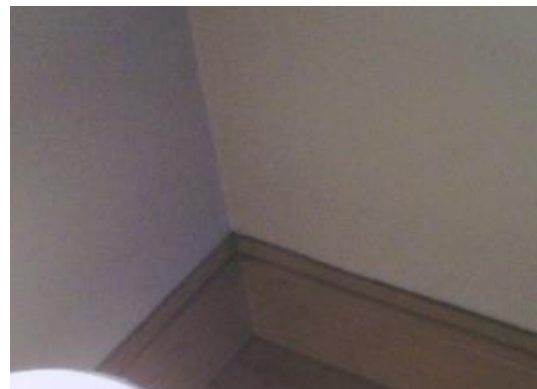
Image three

Image three: Heat loss visible of 10°C

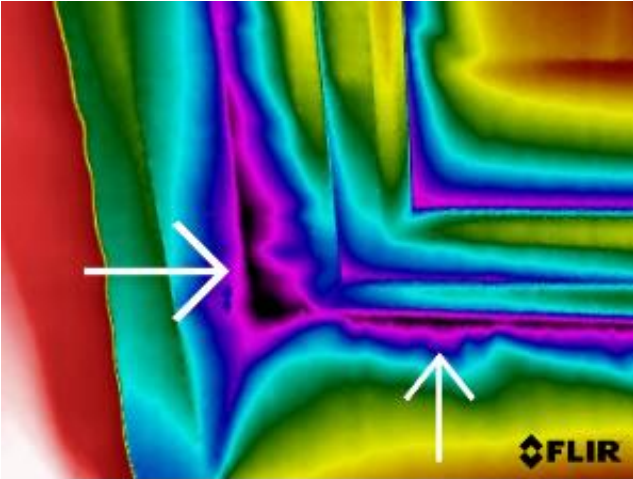
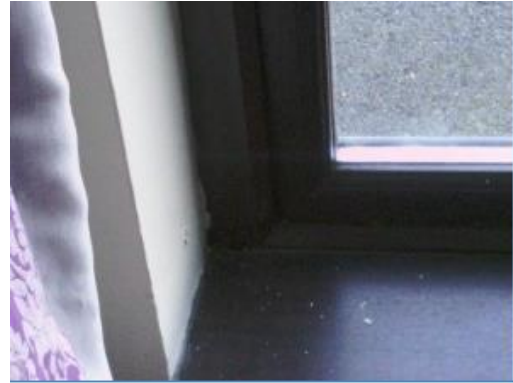
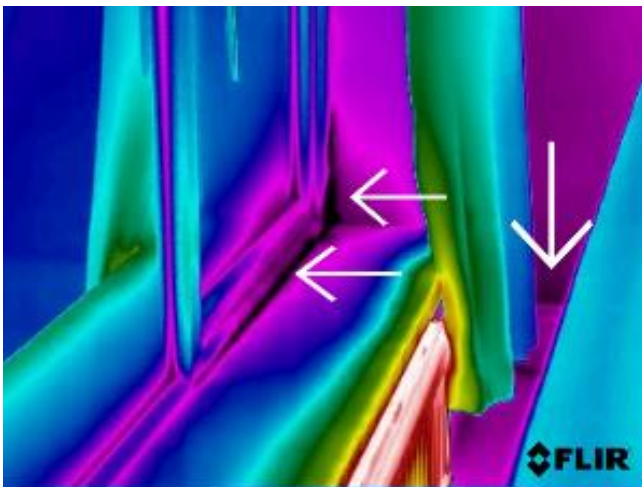
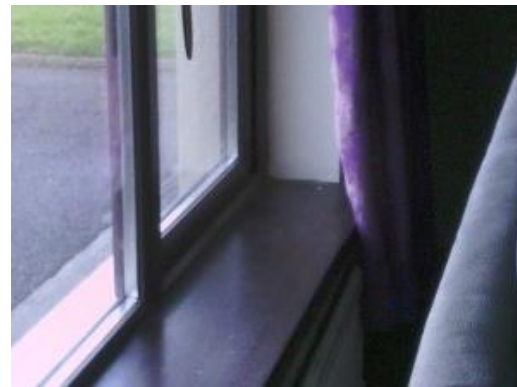
Image four and five: Air filtration in the corners of the windows of up to 9°C.

The seals on the windows should also be looked at as there is air filtration in the corners.

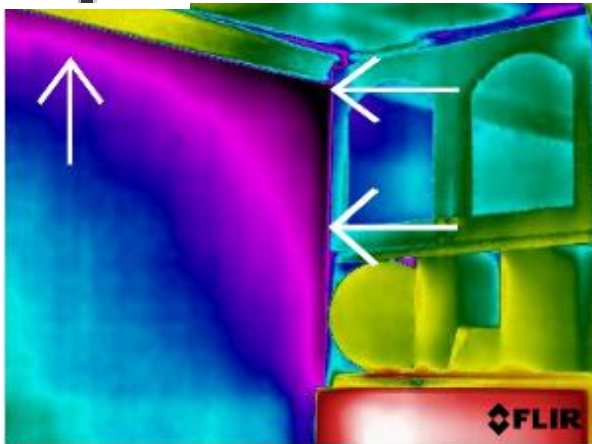
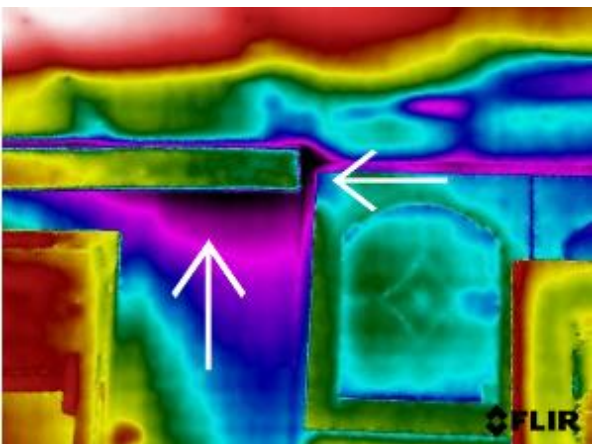
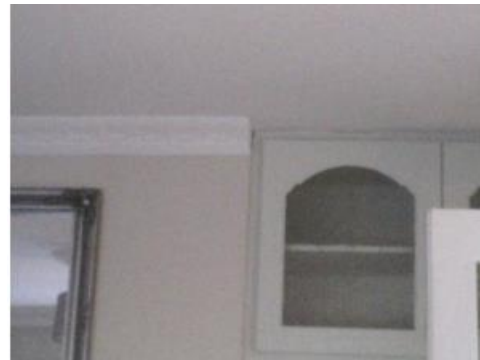
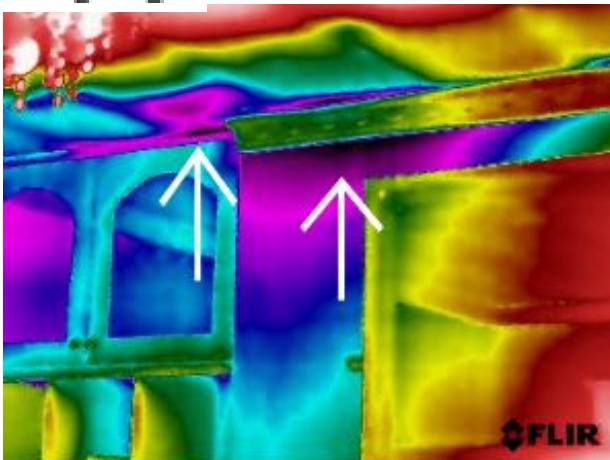
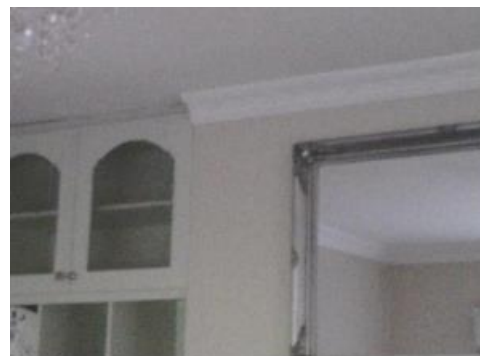
Image six, seven and eight: Heat loss can be seen as the black in these images either side of the top of the chimney breast and the top left corner above the tv.

There seems to be areas of heat loss in the corners of the room and in the areas of purple/black in the images. This may be due to issues with insufficient insulation that should be investigated further.

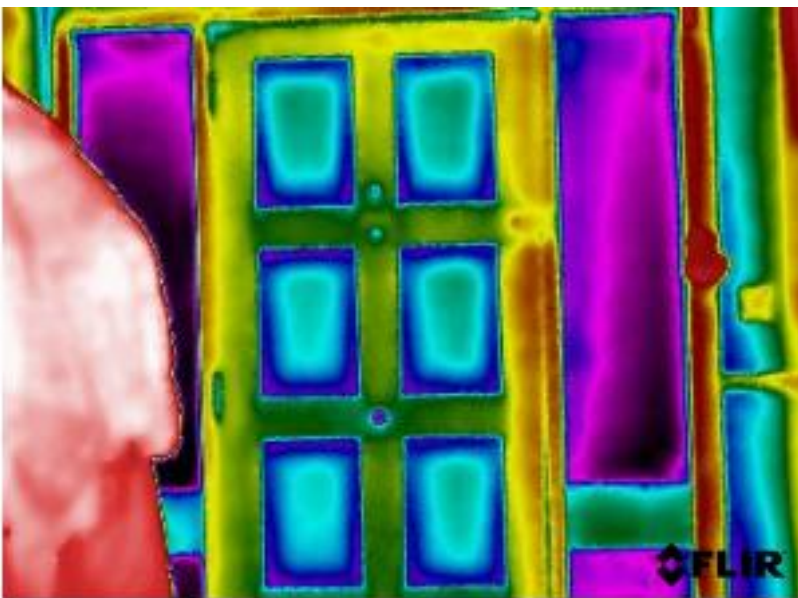
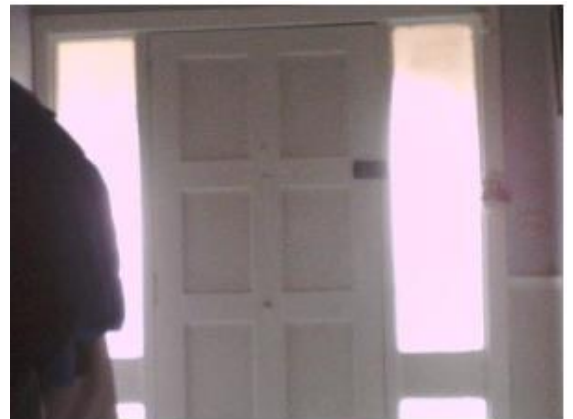
Location: Front Door

It is clear from this image of the front door that there is significant heat loss from the window panes. It might be beneficial to look at upgrading the glass panels here. Temperature loss of 10°C.

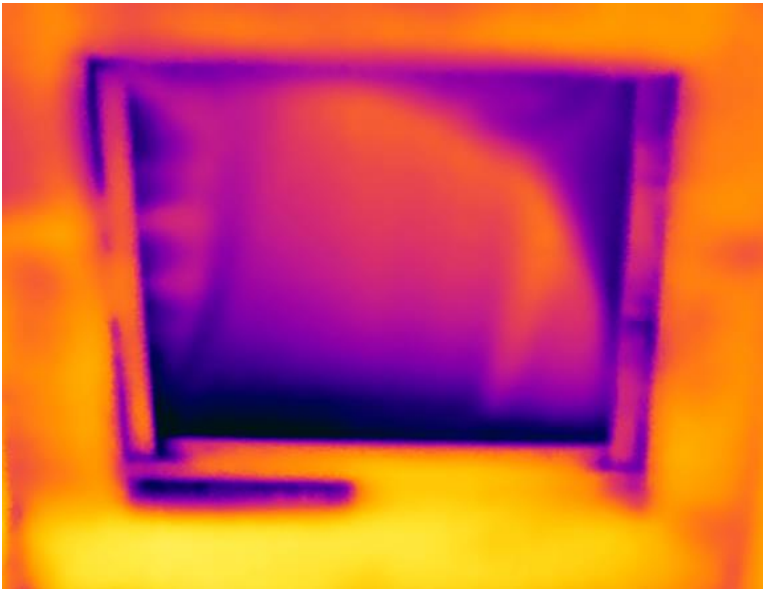
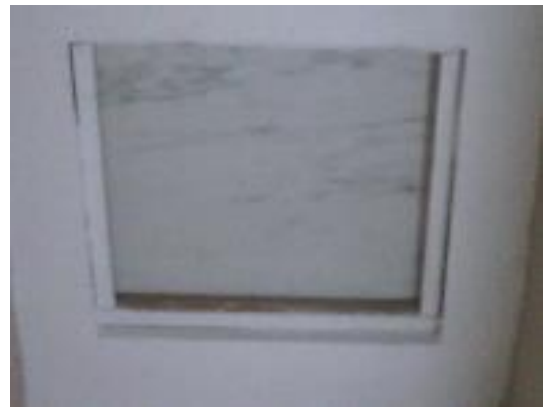
Location: Attic door in the hall

This makeshift attic door is a source of major heat loss in the home.

It would be beneficial to consider replacing this and have a door with seals in its place if possible.
