MIDLANDS THERMAL IMAGING

**This Inspection was
carried out on a home in
Rathcabbin, Roscrea, Co.
Tipperary**

This report has been completed by Katie Masterson.

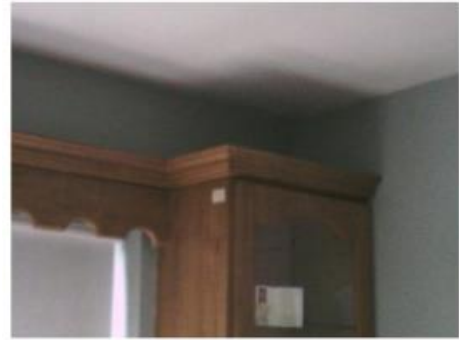
Image three

Image three: A closer look at the cold spot above the kitchen cabinet in image two. It seems to run along the top of the wall and meeting with the problem area in the next image.

Overall, the inspections indicate the kitchen the window seals may need to be looked at as it seems there are spots of air filtration. There is also heat loss running along the top of the walls which may be due to insufficient insulation however this should be investigated further. There is significant heat loss above the extractor fan area which may be from an air vent from the extractor fan.

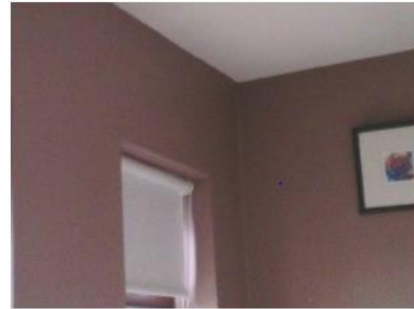
Image three

Image three: I have selected a different colour palette on this image to highlight the difference in temperature running along the top of the utility wall which can be seen as the darker area. There is up to 7°C heat loss in this area.

The images highlight a draft coming through areas of the back door which may indicate that the seal on the door may need replacing. The heat loss running along the top of the wall may be due to insufficient insulation and may require more advise.

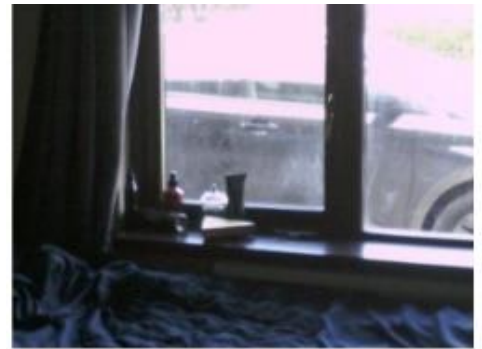
Image three

Image three: It is obvious from this image that there is heat loss here. The temperature drops up to 9°C in the corner of the window.

The inspection of this room has shown heat loss in the top corners of the wall to the front of the house. It seems that this heat loss runs across the top of the window. This is most likely caused by issues with insufficient insulation in this area, however, this should be investigated further. There is obvious air filtration around the window which may be due to the seals needing replacing.

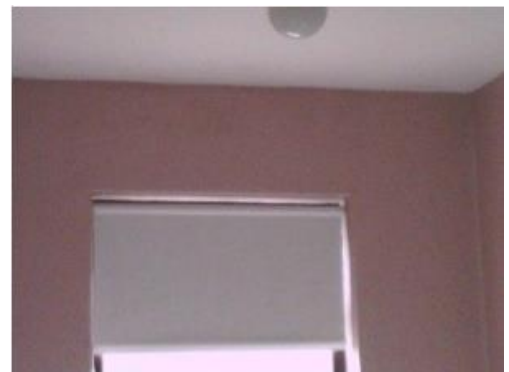
Image two

Image two: There is another large area of air filtration appearing in the bottom right side of the window with a temperature drop of 6°C. It appears there is heat being lost from beneath the window also as shown in the purple colour in the image.

The inspection in the bathroom shows areas of heat loss around the windows which may be due to issues with the sealing. It seems to be becoming a common issue in the walls above and below the windows are losing heat which may be due to insufficient insulation which should be investigated further.

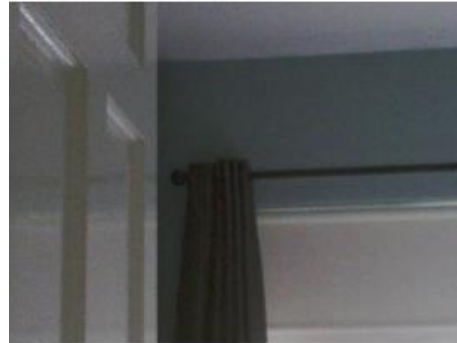
Image one

Image one: This image shows problems with heat loss at its most in the corner however runs across the top of the window.

In this room there is that cold spot running across the wall between the window and ceiling which may be due to issues with insulation that should be investigated further. It is also clear that there is cold air coming through the base and into the corner of the window which can be caused by a poor seal on the window.

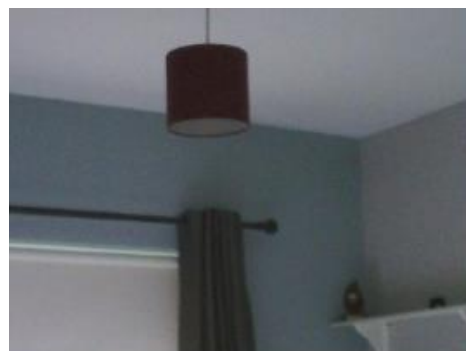
Image two

Image two: Heat loss appearing across the top of the window and to the corner of the room. Temperature difference of 7°C in this area.

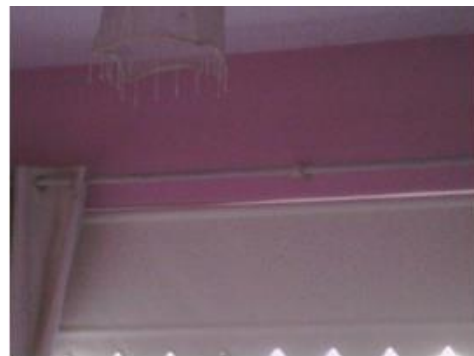
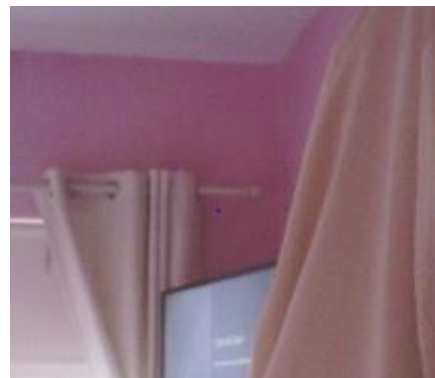
Image one and two: Obvious heat loss above the windows here. There is a temperature drop of 8°C.

The inspection in this room indicated that there may be issues with insulation. The areas of heat loss seem to be mostly the top, bottom, and corners of the back wall as well as the sites above and below the window, however it should be advised that this be investigated further. The radiator needs attention in this room. It may need to be bled.

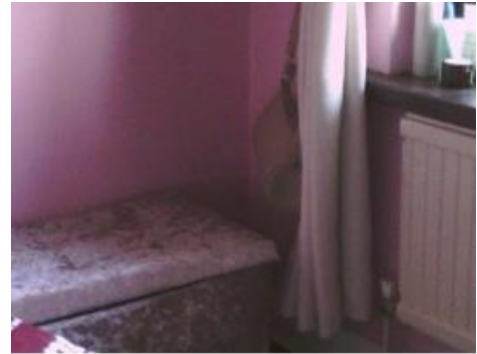
Image three

Image three: Shows heat loss in the corner of the room and towards the skirting board which is highlighted in the next image.

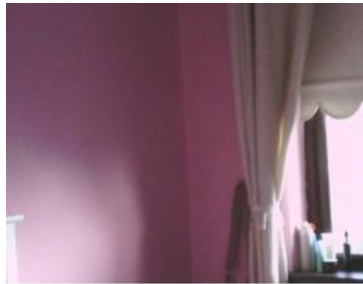
Image five

Image five: Loss of heat appearing in the corner of this room from top to bottom.

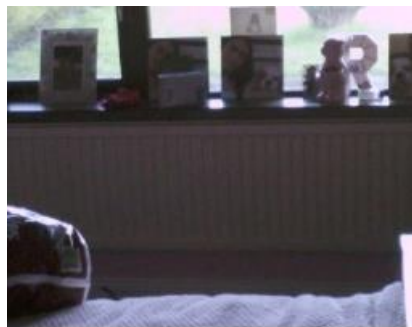
Image six

Image six: The radiator is not working at full capacity.

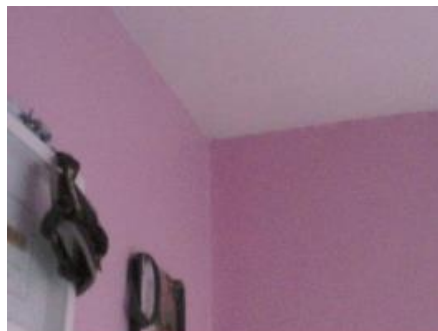
Image seven

Image seven: Cold spot is visible in top right corner of the room. The temperature difference here in 9°C.

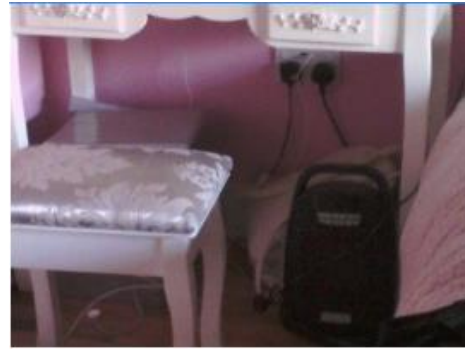
Image eight

Image eight: Cold spot can be seen behind vanity. Probably the same case as image four with the skirting board in this room.

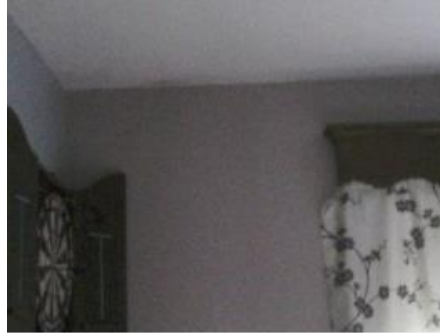
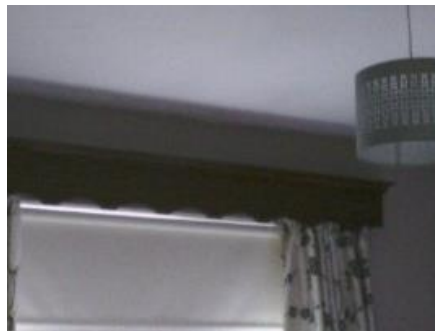
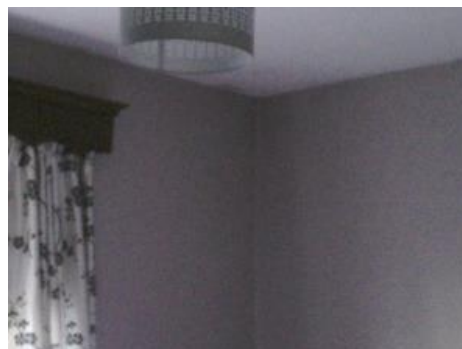
Image one, two and three: Loss of heat running between top of window and ceiling that continues across the back wall. Temperature difference is 8 °C in this area.

The inspection in this room reveals that there is significant heat loss in the corners of the room and as seen in other rooms there is a section running above the window that may be due to lack of insulation that may need to be looked at further. There is heat being lost also along the skirting boards in this room and can be seen in the back wall, in the corners and along the bottom the walls. This may also be from insufficient insulation that requires more advise. The radiator might need to be bled as there is a cold spot that can be seen in the centre.

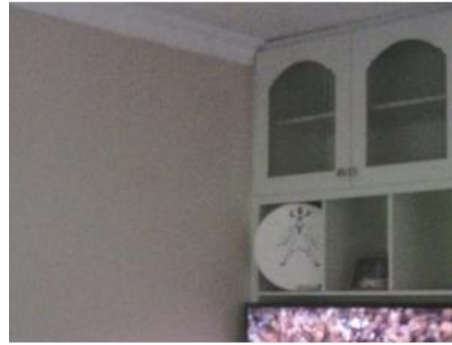
Image six

Image six, seven and eight: Heat loss can be seen as the black in these images either side of the top of the chimney breast and the top left corner above the tv.

There seems to be areas of heat loss in the corners of the room and in the areas of purple/black in the images. This may be due to issues with insufficient insulation that should be investigated further.
